COUNTRY	USSR (Dnepropetrovsk Oblast)	REPORT	
SUBJECT	1. Petrovsk Metallurgical Plant in Dnepropetrovsk	DATE DISTR.	7 April 1959
	2. Karl Libknekht Metallurgical Plant in Dnepropetrovsk	NO. PAGES	2
	3. Auto-Transport Repair Shop No. Two in Dnepropetrovsk	REFERENCES	
DATE OF INFO.			25X1
PLACE & DATE ACQ.			25X1

THE PETROVSK METALLURGICAL PLANT IN DNEPROPETROVSK

Auto-transport Repair Shop No. 2 in
Dnepropetrovsk

THE KARLA LIBKNEKHTA METALLURGICAL PLANT IN DNEPROPETROVSK

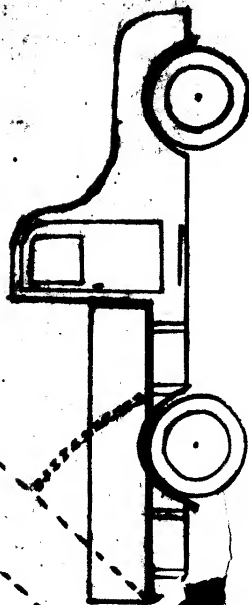
Sketch of trucks of A.T.A. no 2

GAZ 51, 2.5-ton dump truck

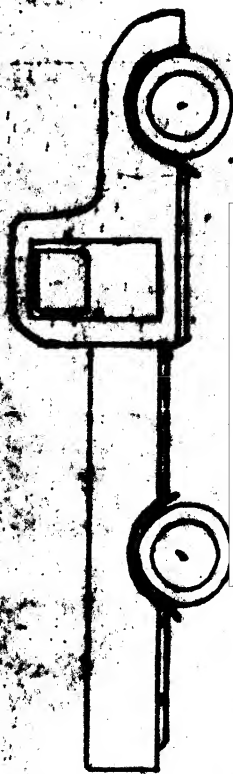
KAZ 150, 5-ton truck

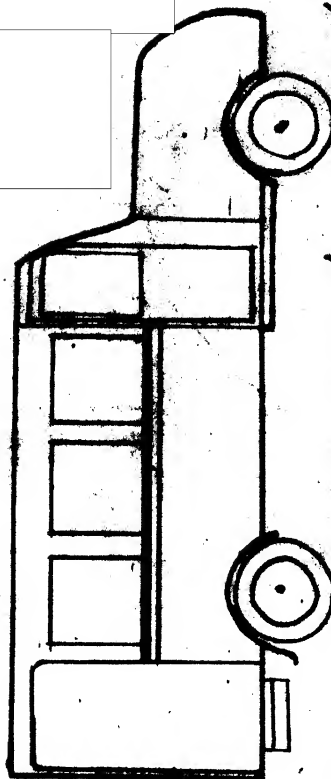
Bus manufactured by the Auto-plant in Dnepropetrovsk until 1951 when the plant was converted to military work.

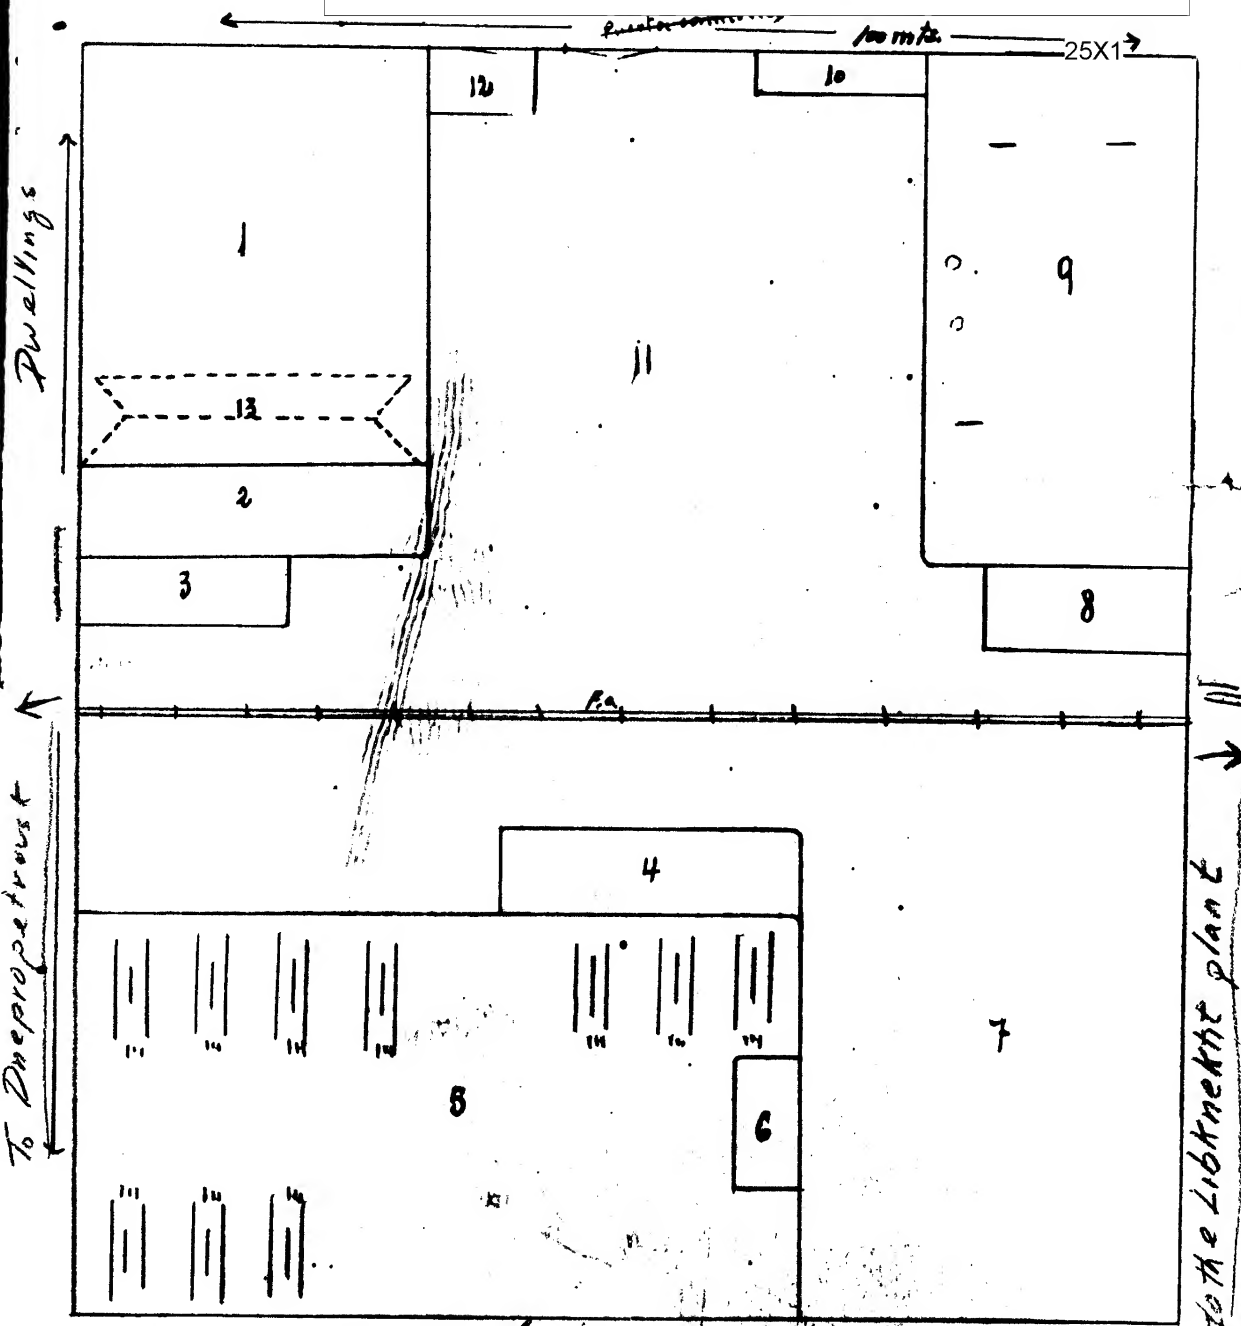
Sketch of the M.I.I.
in Dnepropetrovsk

2. The Auto-transport Repair Shop No. 2 consisted of shops occupying an area of some 100 x 150 meters facing ulitsa Kolonna and bounded on three sides by other buildings or by a 2.5 meter wall. There was a vehicle entrance and a personnel entrance and a railroad line crossed the center of the installation. The margin numbers in parenthesis below refer to

- (1) Service Yard. This was a 30 x 50 meter area where the automatic gasoline and oil pumps for servicing the vehicles which were in the shop to be repaired. There was a 50-ton capacity underground reserve tank for gasoline and a ten-ton capacity tank for oil. The pumps were protected from the weather by a small cover. The service area was separated from the central yard by a small brick wall with wooden gates.
- (2) Electrical shop. This was a 16 x 30 meter, covered building dedicated to electrical repairs and the storage of electrical

- (3) Shower room.
- (4) Welding shop. Six workers did electric and acetylene welding in this shop.
- (5) Repair shop. The repair shop was a one-story, brick building, 12 meters high which measured 72 x 75 meters with a metal and fire-resistant glass roof. The shop was equipped with 10 to 12 grease pits with their corresponding car lifts for working underneath the trucks; air compressors for filling tires, cleaning, painting, and grease guns; running water; and drains. About 50 workers were employed here.

- (6) Tool storage. A section of the repair shop was used for tool storage.
- (7) Truck body yard. Between the repair shop and the outer wall was a yard equipped with a chain-type, hand crane mounted on a metal frame which was used for dismounting truck bodies. The truck bodies were stored here while the motor and chassis were being repaired.

- (8) Spare parts stores. Tires and spare parts for the repair work were stored here.
- (9) Machine shop. This shop, which measured approximately 50 x 30 meters employed 30 workers and was equipped with 3 Soviet-make lathes, 2 drilling machines, a small milling machine, finishing table, and a small forge.

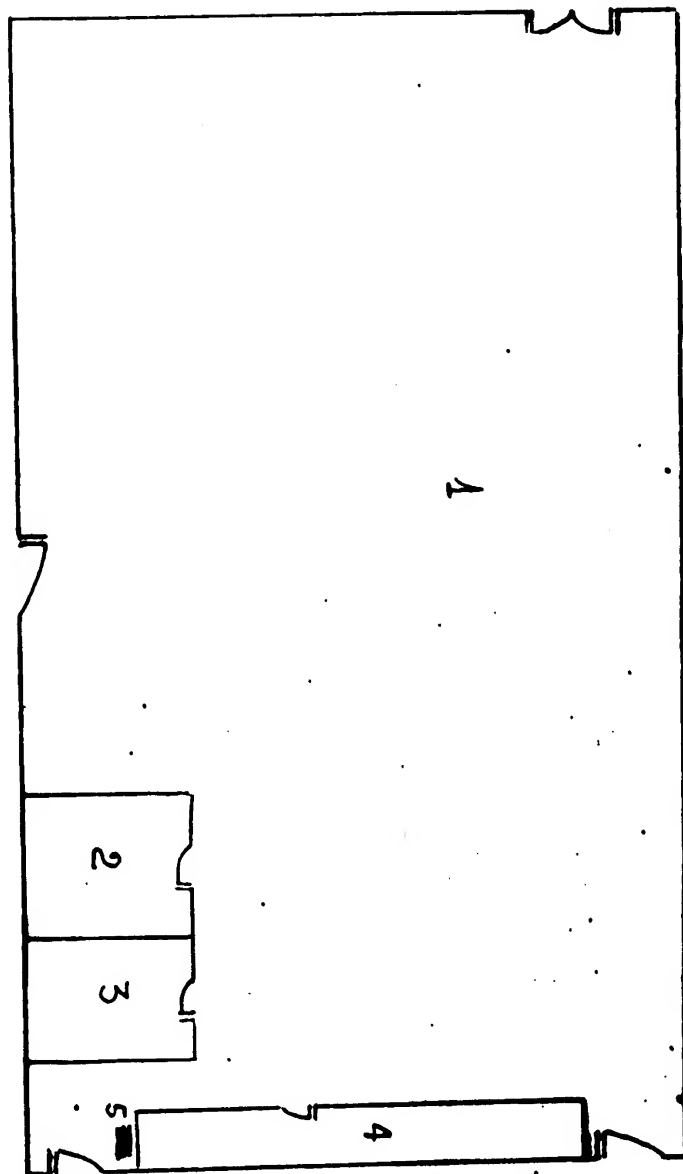
Sketch of Machine Shop

The machine shop was a rectangular, one-story brick and concrete structure measuring approximately 45 x 20 x 9 meters, roofed with tar-surfaced reinforced concrete. It had no basement. The machinery included Soviet and German-made lathes, and milling machines and planers of unknown make and number. The shop, which produced gears and spare machine parts, operated on a three-shift, 46-hour week schedule and employed about 250 workers -- 100 on the first shift and 75 each on the second and third shifts. The employees worked six hours on Saturdays. Workers were generally granted leave on request provided it did not interfere with shop operations. Employees with less than three years service received 12 days annual leave plus holidays, and employees with more than three years service were given 15 days plus holidays. Persons with unhealthy jobs were given one month's vacation. Health conditions on the whole were good: two ambulances provided ambulance service to a polyclinic located outside the plant and each shop was supplied with an emergency first aid kit; moreover, health personnel inspected the meals served in the plant dining room daily. The following monthly salary scale was in effect in the machine shop:

- Ar Sección de Fornos. KATHE SECTION
 2: Sección de plásticos e instrumentos. TOOL MAINTENANCE
 3: Almacén de herramientas. TOOL SHED
 4: Vestuarios CLOAKROOMS
 5: Escaleras STAIRCASE
 6: Ringing room. Red CORNER
 7: Oficina de rentabilidad ACCOUNTING OFFICE
 8: Oficina de detalle OFFICE OF THE SHOP CHIEF
 9: Oficina de planificación PLANNING OFFICE
 10: Oficina de personal PERSONNEL OFFICE

The plant's installations included a foundry equipped with Martin furnaces, a pipe-drawing shop, a shop where railroad car wheels were made, and a machine shop. (See paragraph 4 below for description of machine shop and also sketch showing layout of machine shop.) In the proximity of the plant's foundry were five 30-meter high smokestacks, one of iron and four of brick.

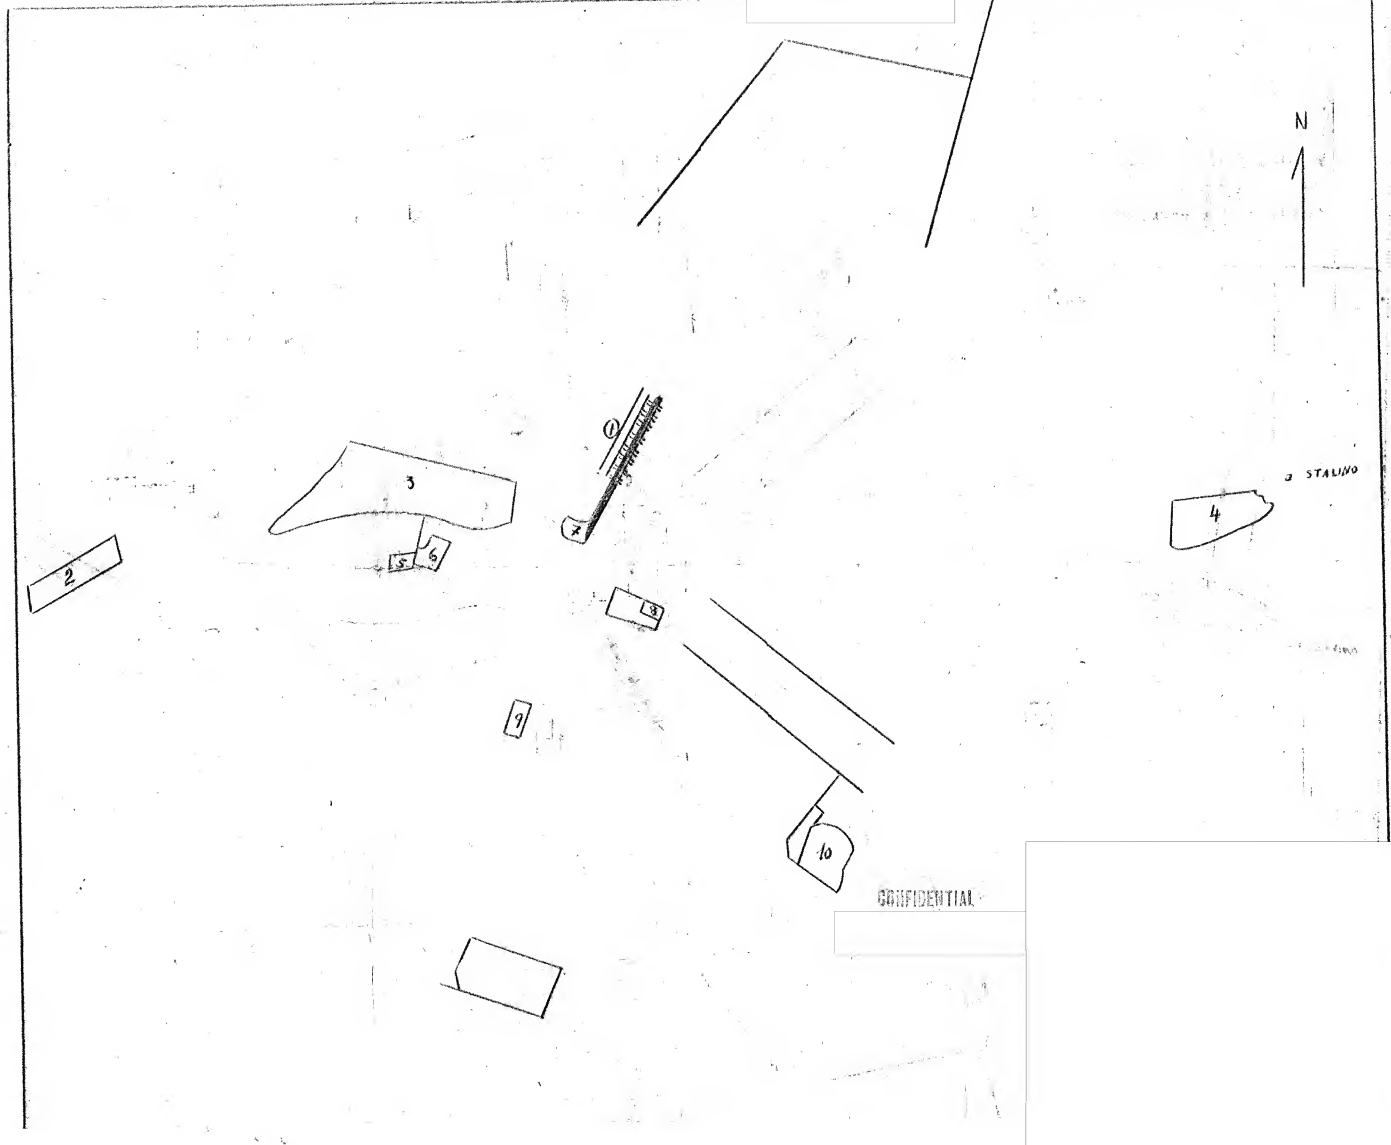
Sketch no. 1. Attachment I

Legend for Sketch No. 1 - The Layout of Petrovsk Metallurgical Plant

1. Coke-burning, mechanically-operated blast furnaces which were used to smelt crude iron. Each had a perimeter of some 500 meters and a capacity of 1,500 cubic meters.
2. A brick building on a metal framework (like others in the plant); in which ingot iron was transformed into rails and angle irons.
3. In this building were Martin furnaces in which crude iron was smelted and then passed on to No. 4 below.
4. The "Bessemer" building, where steel ingots, a half meter long and weighing about 30 to 40 kilograms each were produced.

8. Machine shop. [] it contained lathes, milling 25X1
machines, planers, and die stampers but did not know their
size, shape or other characteristics.

9. Power plant, about 800 meters long and 600 meters wide. It
not only supplied the plant but, during periods of restriction,
the entire city of Dnepropetrovsk. The power plant was a re-
stricted area.

14. Platform where freight was loaded and unloaded. A 50 MT
mobile
capacity/crane was stationed here.

15. ~~Three~~ 100-meter high brick smokestacks with 20-meter perimeters
for the blast furnaces; the latter were connected by an under-
ground passageway.

1. The Petrovsk Metallurgical Plant (Zavod Petrovskogo), located on Mira ulitsa in the city of Dnepropetrovsk (N 48-28, E 35-00), Dnepropetrovskaya oblast, was subordinate to the Ministry of Ferrous Metallurgy. During the period covered by the report it was called the Zavod Petrovskogo but, prior to the Russian Revolution, had been known by other names, the Brianski, for example. It had no numerical designation. It occupied an area about five or six kilometers long and three or four kilometers wide near a bridge (see point 1 on sketch 2) which spanned the Dnepr River. It was surrounded by a three-meter-high wall, with the main entrance gate in the middle of Mira ulitsa; there were, moreover, about ten other gates used by plant personnel plus gates for the steam railroad line which connected with the Dnepropetrovsk railroad station. The plant consisted of 11 main buildings, four old small structures, a power plant, eight blast furnaces, and freight loading platforms, all of which are described in the legend for sketch No. 1 (see pages 3 & 4).
